Lightning and Surge Protection of Photovoltaic Installations

Two Case Histories: Vulcano and Kythnos

François D. Martzloff
National Institute of Standards and Technology

NISTIR-89 - 4113

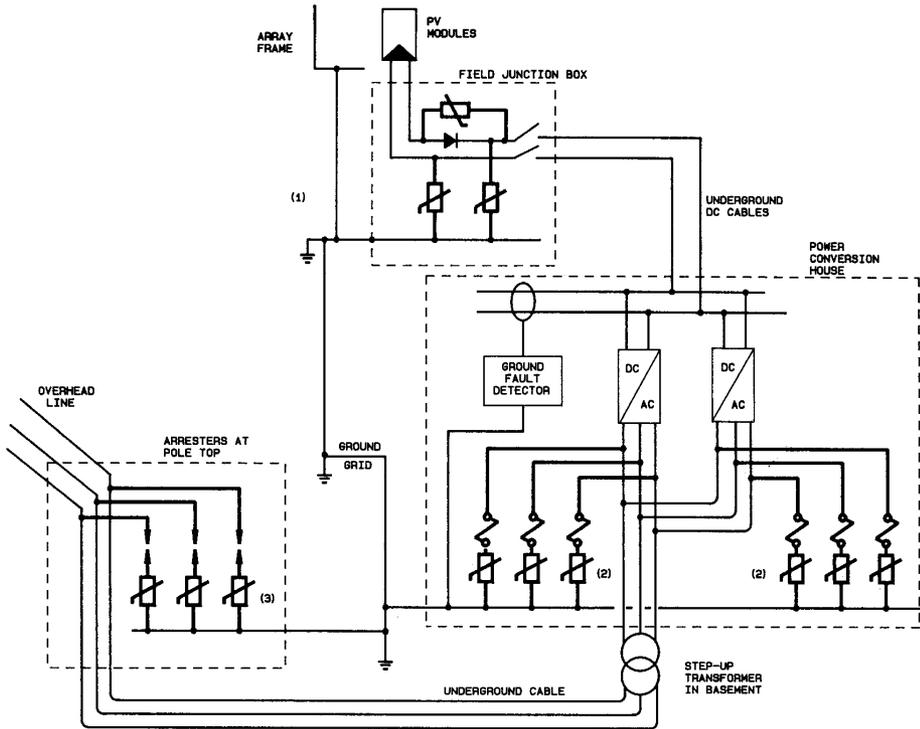
Figure 2-2. Surge protective devices at system interfaces

In the Vulcano system, the dc system is not grounded. A ground fault detection system is provided (Figure 2-2), with alarm indication on the control panel (Photograph 2-3) but no automatic trip nor remote indication of the fault condition (the system is unattended). Experience with this system is described as satisfactory after an initial period of reported difficulties associated with insulation deficiencies in the panels. (These were eventually corrected by field or factory rework on the panels.)

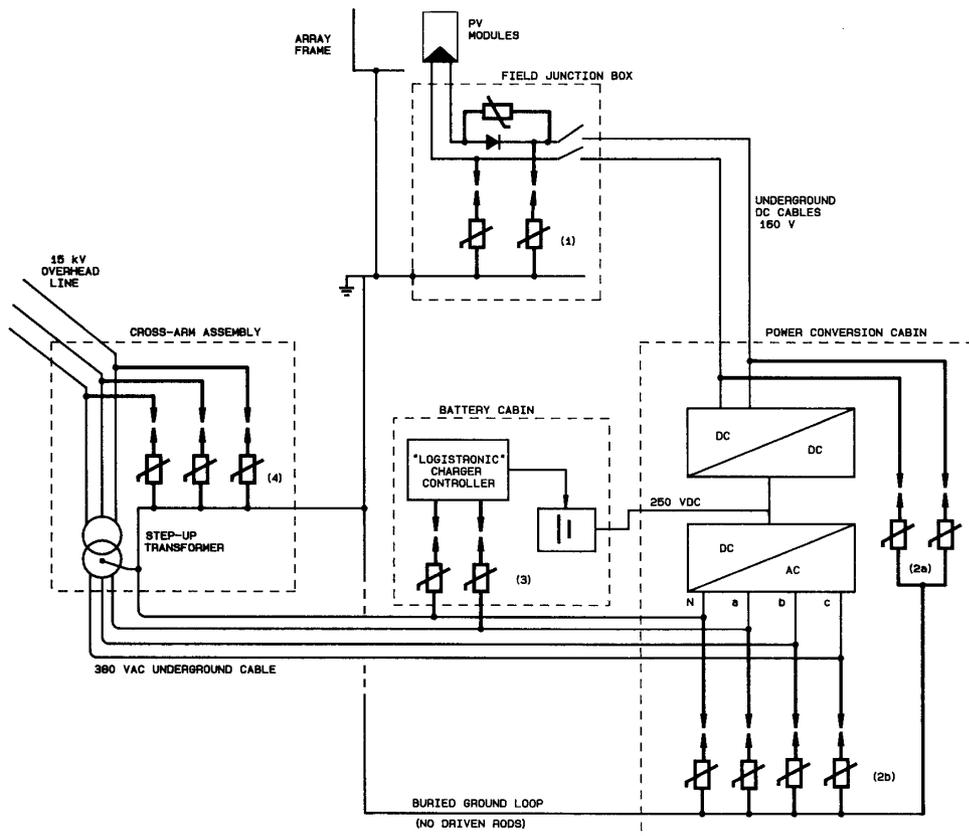
Figure 3-3. Overvoltage protection at system interfaces

raises the question of a possible difference of ground potential between these two systems during a lightning strike. If instrumentation or telemetering equipment spans across the two systems, the difference in ground potentials might become a problem. However, no such problem was identified at that site.

This installation presents an interesting case history because it includes both lightning rods (air terminals) in the array and surge arresters in the circuits. Damage to several panels, presumably as a result of lightning over a period involving three separate occurrences, raises questions on the effectiveness of the protection against direct strikes. Damage to the surge arresters also occurred in one of the field junction boxes, but no damage occurred on the power conversion units. Some damage occurred in the control circuits of the battery charger during the initial period, when they did

not have surge arresters at their ac power input. After arresters were added to this ac input, no further damage events occurred but some upsets did still occur in the control system.

The string blocking diodes are mounted in the junction box and are protected by a metal-oxide varistor connected in parallel with each diode (Photograph 3-8). Photograph 3-9 shows another junction box with the additional data collection circuitry installed in the box cover. This particular box is the one where the lightning-suspected damage occurred, as shown in the close-up views of Photographs 3-10 and 3-11.

(3) At the Logistronic circuit power supply - The "Logistronic" circuit controlling the battery charger is powered from the 220 V ac line in the battery cabin. Thus, its power supply is exposed to surges that may occur on that supply. Initially, there was no protection on this ac supply; perhaps as a consequence, damage occurred three times in the early years of the system (Appendix B). Subsequently, two arresters were installed on the ac supply line ahead of the Logistronic input terminals (Photograph 3-14). After these ac arresters were installed, only upsets were recorded (four occurrences). This behavior is consistent with the voltage-limiting effect of the arresters but at the price of a steep voltage collapse when the gaps fire (Appendix C). This electromagnetic disturbance is a likely source of interference in nearby digital circuits.
