Lightning and Surge Protection of Photovoltaic Installations

Two Case Histories: Vulcano and Kythnos

François D. Martzloff
National Institute of Standards and Technology

NISTIR-89 - 4113

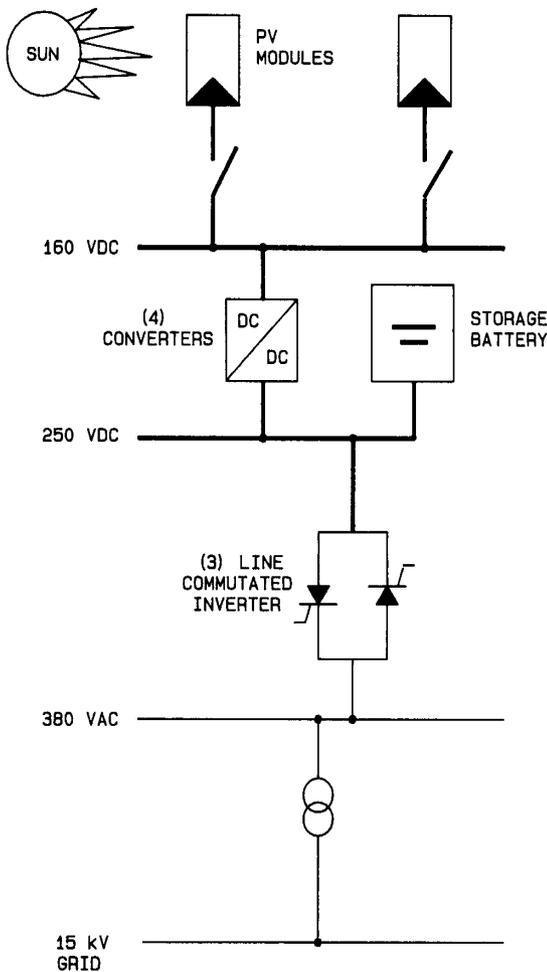
Figure 3-1. Block diagram of the Kythnos photovoltaic system

The installation was designed and implemented by Siemens, as one of the experimental facilities coordinated by the European Economic Community (Photograph 3-1). The plant has a nominal output capacity of 100 kW. Figure 3-1 shows a schematic of the system components. The modules are grouped in arrays formed by a series string of 20 modules, each producing a dc bus voltage of 160 V. Each of these 43 arrays is terminated in a junction box in the field, where two or three strings are connected in parallel to bring the dc power to the power conversion cabin (Photograph 3-2).
